Case of the Month

June 2024

Dr. Shui-wah, Man

A Case of Application of 3D Printing in Management of Calcaneal Fracture Malunion

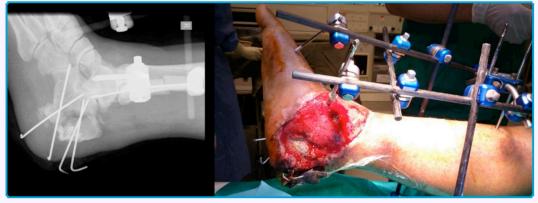
(Fig. 1)
X rays showing right ankle fracture dislocation

Mr. Ray was a 43-year-old local construction site worker. He enjoyed good past health. His right lower limb was crushed by heavy object in an industrial accident in 2015. He sustained right ankle fracture dislocation (*Fig. 1*), leading to right calcaneus open fracture with tissue & bone loss.

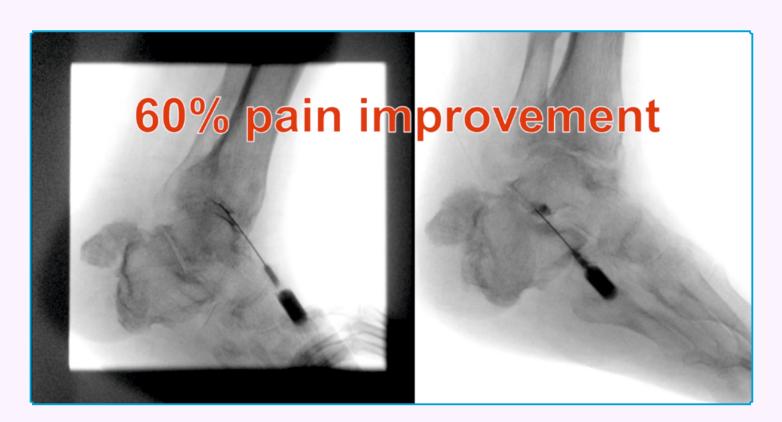
(**Fig. 6**)
X rays showing contrast arthrogram for his ankle and subtalar joint

We performed a contrast arthrogram for his ankle and subtalar joint (*Fig. 6*), which yielded 60% of pain relief.

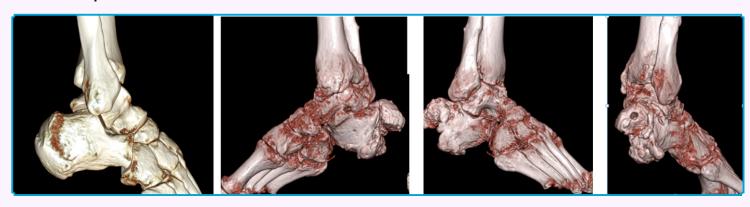
(Fig. 7)
CT scan of his right foot and ankle, with 3D reconstruction were shown

We performed CT scan of his right foot and ankle, with 3D reconstruction (*Fig. 7*). CT scan of the left foot and ankle was also performed at the same time to be as template to guide the right foot reconstruction afterwards (*Fig. 8*).

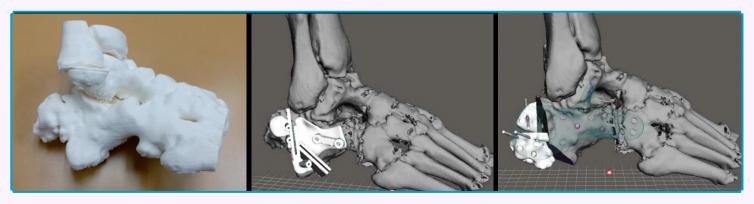
(**Fig. 9**)
A 3D printed cutting guide and temporary internal plate fixation after osteotomy were designed at the same time

We worked with our P&O Department for design of the location of bone cut for corrective osteotomy of the right calcaneum. A 3D printed cutting guide and temporary internal plate fixation after osteotomy were designed at the same time (*Fig. 9*).

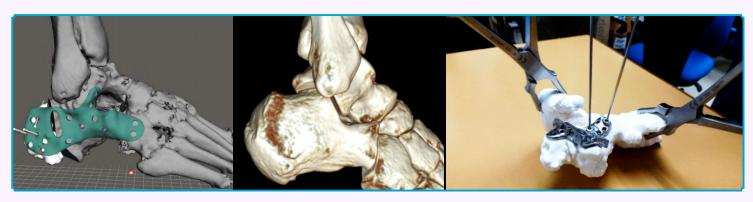
(**Fig. 10**)
Pictures showing a trial cut in the saw bone model

We performed a trial cut in the saw bone model (Fig. 10).

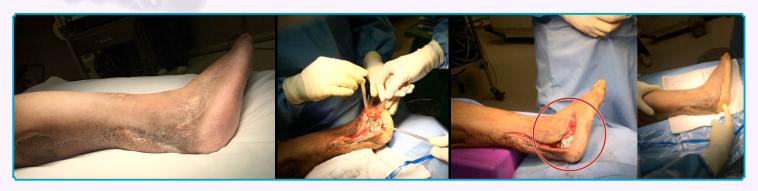
(**Fig. 11**)
Intra-op photos demonstrating the 3D printing cutting guided osteotomy for our patient

Finally, 3D printing cutting guided osteotomy for our patient was performed (*Fig. 11*). Early post-op X-rays showed a very good reconstruction (*Fig. 12*).

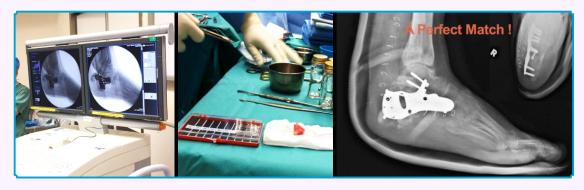
(Fig. 12)
Early post-op X-rays showed a very good reconstruction
